NASA Contractor Report 159261

VISUALIZATION OF IMPACT DAMAGE OF COMPOSITE
PLATES BY MEANS OF THE MOIRÉ TECHNIQUE

W. G. Knauss, C. D. Babcock,
and H. Chai

NASA Grant NSG-1483
April 1980

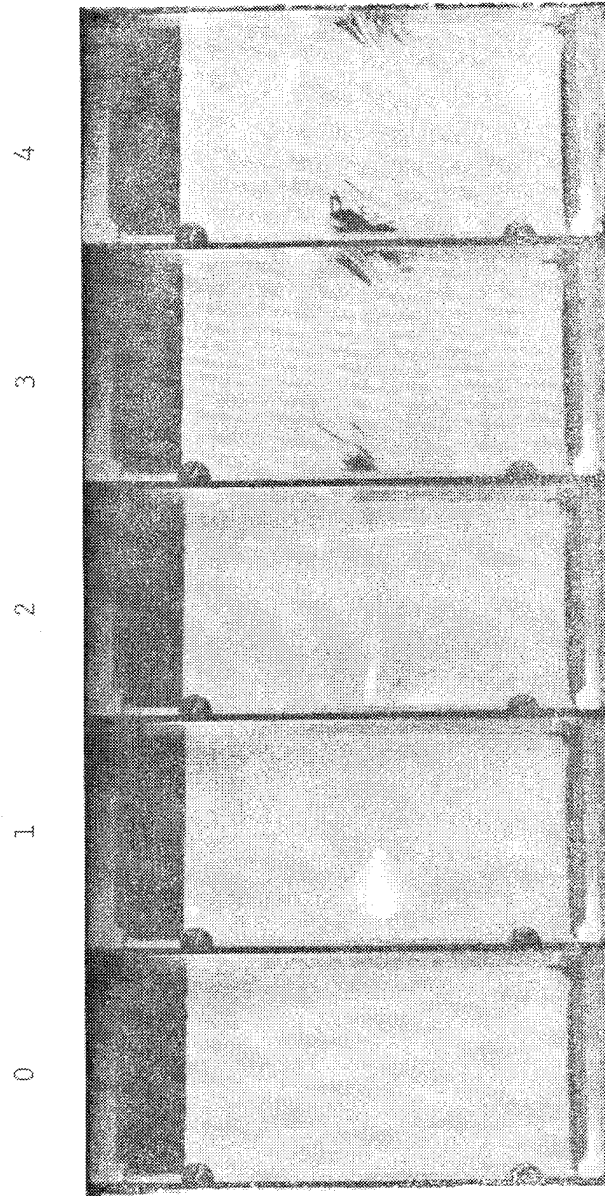
Fig. 7 Test Panel A-2, 9,000 frames/sec.

The first tests were conducted using reflected light photography. Test panel A-2 is shown in fig. 7. The time between frames is 110 μ s. Frame one of this sequence shows what appears to be a bulge in the surface. Extensive damage in the region near the edge is evident in the next frames.

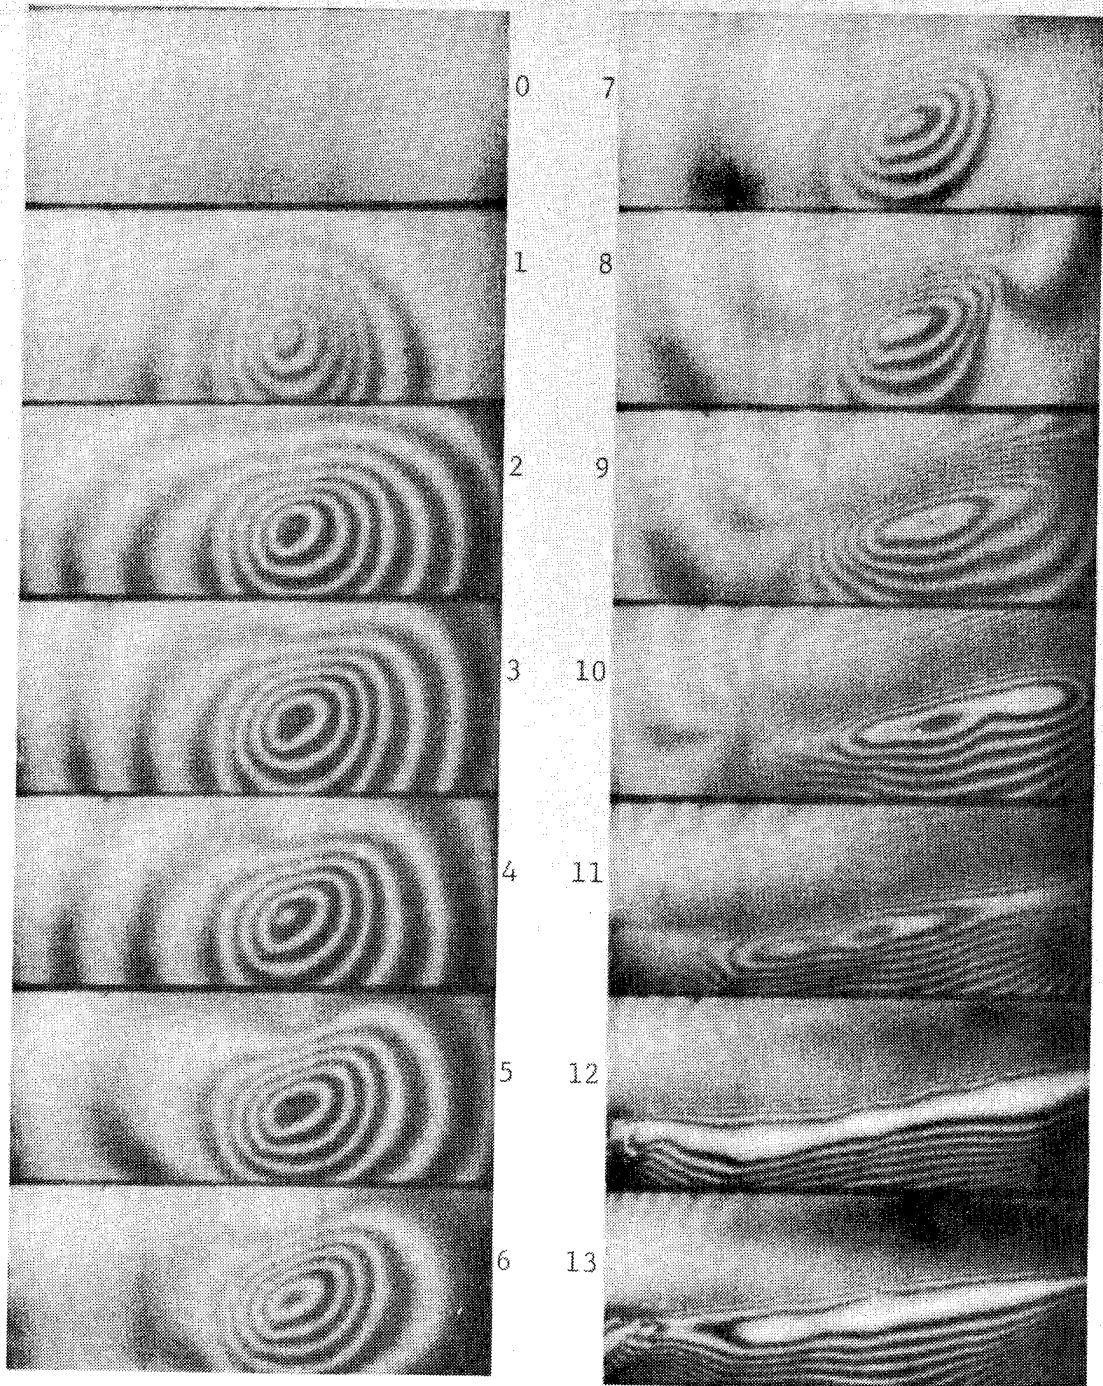
Fig. 8 Test Panel B-2, 16,500 frames/sec.

The results for panel B-2 are shown in fig. 8. The impact point is not centered in the picture. The field of

view is 86 x 29 mm and the time between frames is 61 μ s. The impact causes a peak displacement on the back surface of the order of 1 mm. This displacement changes very little for six frames (≈ 360 μ s) indicating that it represents permanent deformation. Frame 8 shows a rapid growth which is interpreted to be bulging of the outer laminates of the panel. The growth appears to start at a slight angle to the horizontal. This pattern of growth was observed in some but not all subsequent tests. The most distinguishing feature of this sequence of photographs is the delay between the initial damage phase and the subsequent damage propagation phase. This feature will be discussed further in this report.

Another observation of interest has to do with the time at which the damage spreads after initial impact has occurred. In this connection it is well to remember that most of the experiments were conducted in the vicinity of projectile velocity of 60-70 m/sec. According to fig. 6, this falls into the steeper portion of the curve relating failure strain to projectile velocity. For most of the experiments it was quite clear that damage in the form of a displacement peak under the impact point occurred very rapidly but the damage did not spread immediately. For example, in fig. 11 it took something like 24 frames or the equivalent of 1.2 ms before the damage started to grow significantly. After it started to grow, the growth was relatively rapid. Again, by comparison fig. 8 shows that damage did not appear to grow for

approximately eight frames or the equivalent of 0.5 ms and then grew very rapidly. Finally, from fig. 9 it is evident that damage grew almost from the very beginning of impact. While it may on cursory examination appear that there may be two modes under which damage spreads it is believed that this is related to the strain level. Panels that are closer to the threshold curve tend to have an early propagation of the damage area while those further away exhibit a slight delay of propagation.

propagated with approximately the same speed as that which occurred for curve B-6. Finally, the delamination corresponding to test B-2 indicates that no propagation occurred for about seven frames and after that when it did occur it again propagated at approximately the same rate as curves B-7 and B-9. The curves on the left hand part of the figure simply refer to the left most point in the moiré diagram and similar statements hold with regard to these curves. These observations are important because they support the intuitive feeling that the propagation problem is separate from the problem of damage generation. If this statement can be further supported and accepted it would basically make it possible to treat the damage propagation problem separate from the impact problem, which has great analytical advantages.

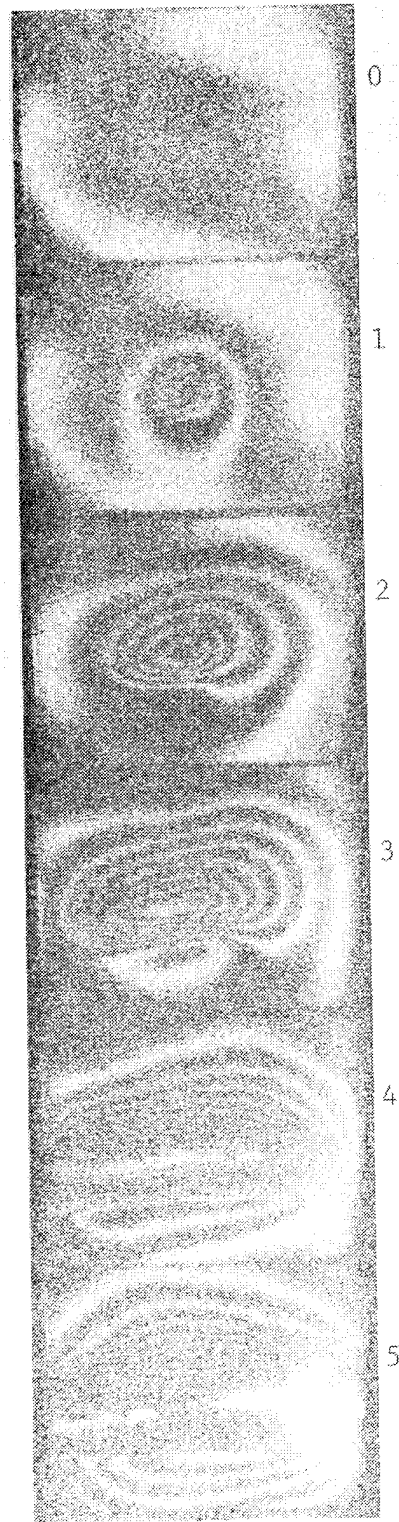
Fig. 9 Test Panel B-6, 20,000 frames/sec.

The results for test panels B-6 and B-9 are shown in figs. 9 and 10. These photographs show larger fields of view than that for B-2. The sequence of events is much the same as before but the time delay is different. B-6 (fig. 9) shows a delay of less than 50 μ s (the time between frames) while B-9 exhibits a slow growth for about 200 μ s, followed by a large deformation of the back surface.

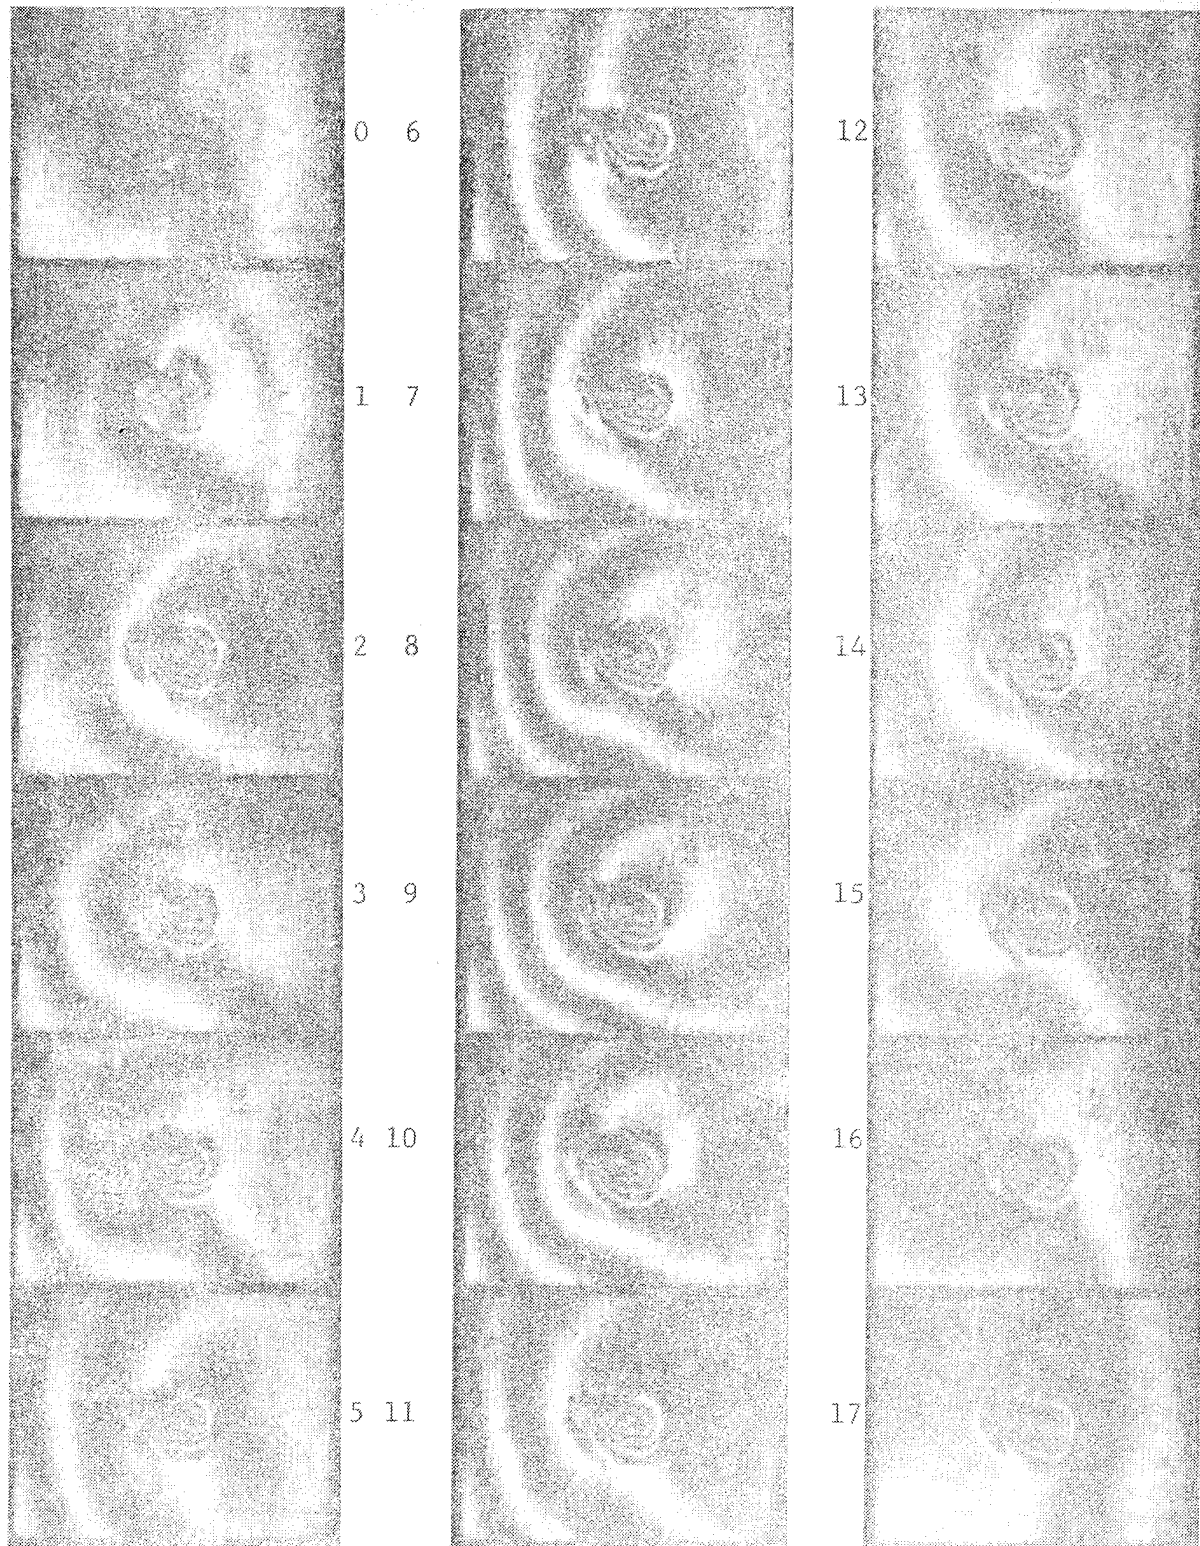
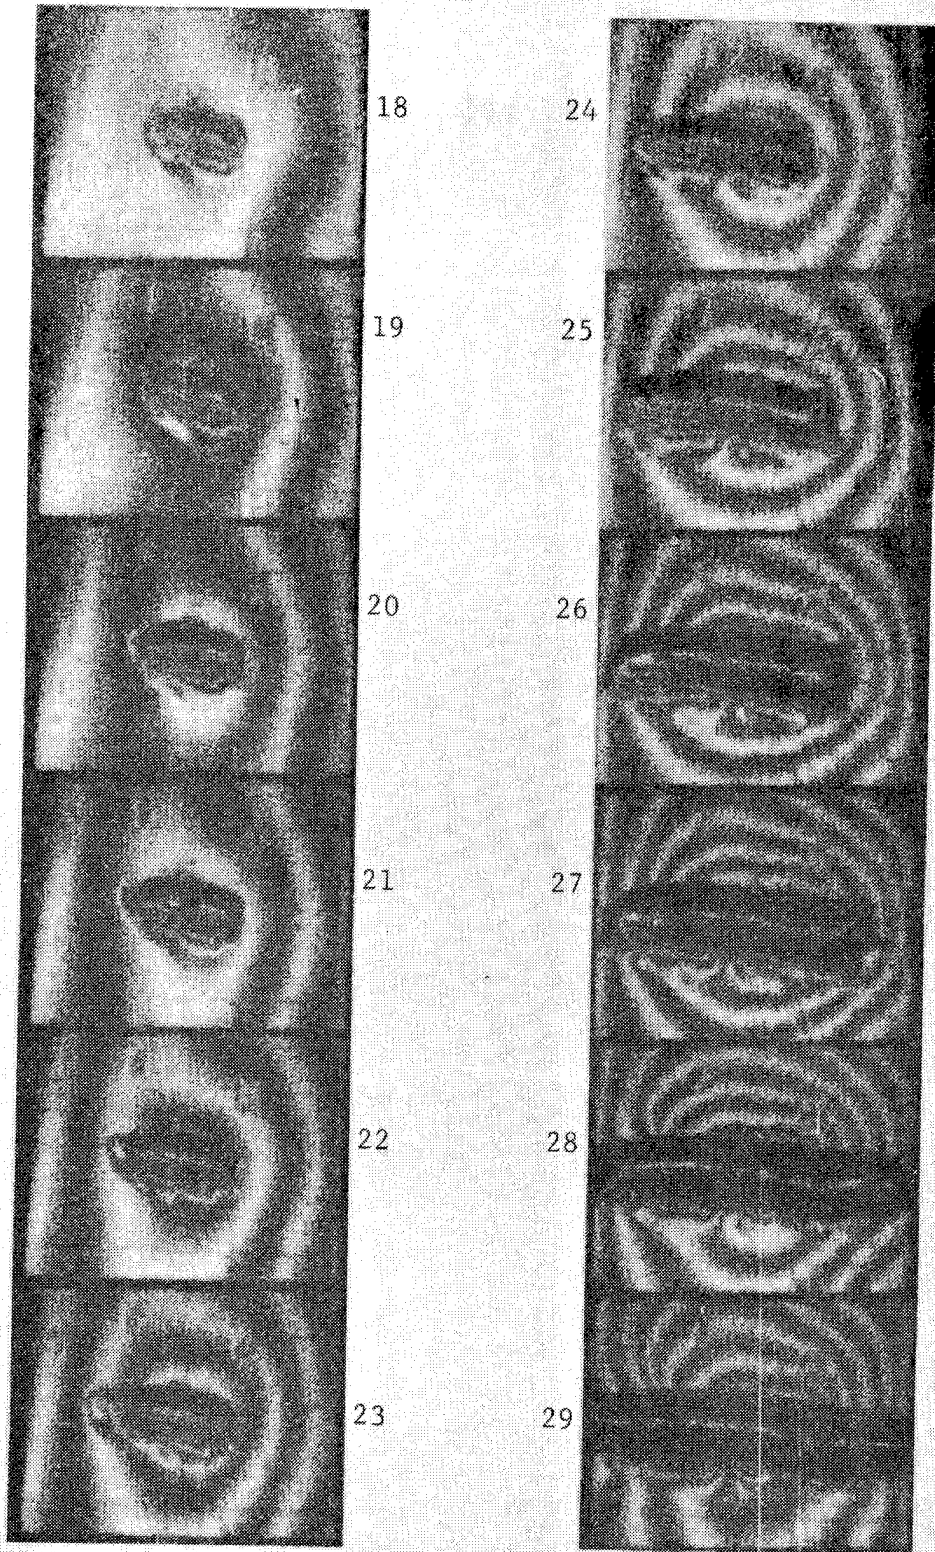
Fig. 11 Test Panel C-2, 19,000 frames/sec.

Figure 11 shows the moiré photographs for test panel C-2. This panel is larger than those previously discussed (254 x 152 mm vs. 203 x 101 mm). The fringe quality is not particularly good for this series of photographs but the sequence of events can be detected. The rapid growth of the damage area does not begin until frame 24 (1200 μ s). Prior to this the damage area is almost stationary with a slow

growth beginning in frame 17. Superimposed on this "permanent" deformation is what appears to be a plate vibration motion. The half period (ending in frame 16) corresponds to a frequency of about 600 Hz.

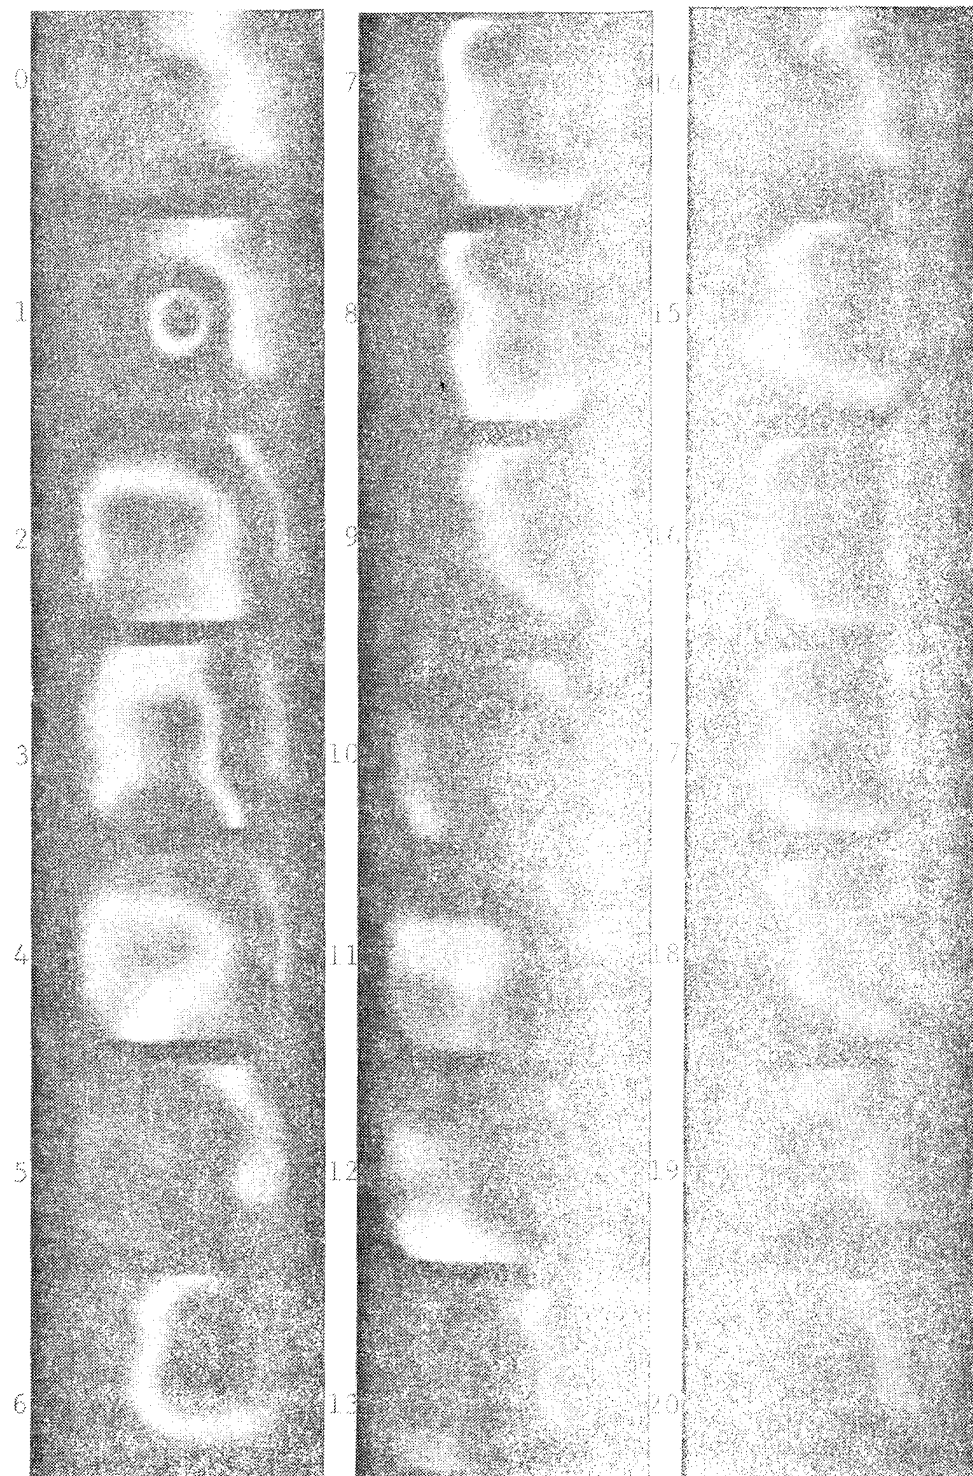
Fig. 12 Test Panel B-5, 20,000 frames/sec.

A photo sequence of an unloaded test panel (B-5) is shown in fig. 12. The maximum surface displacement observed was about 0.25 mm. No permanent deformation was observed from the moiré photograph.

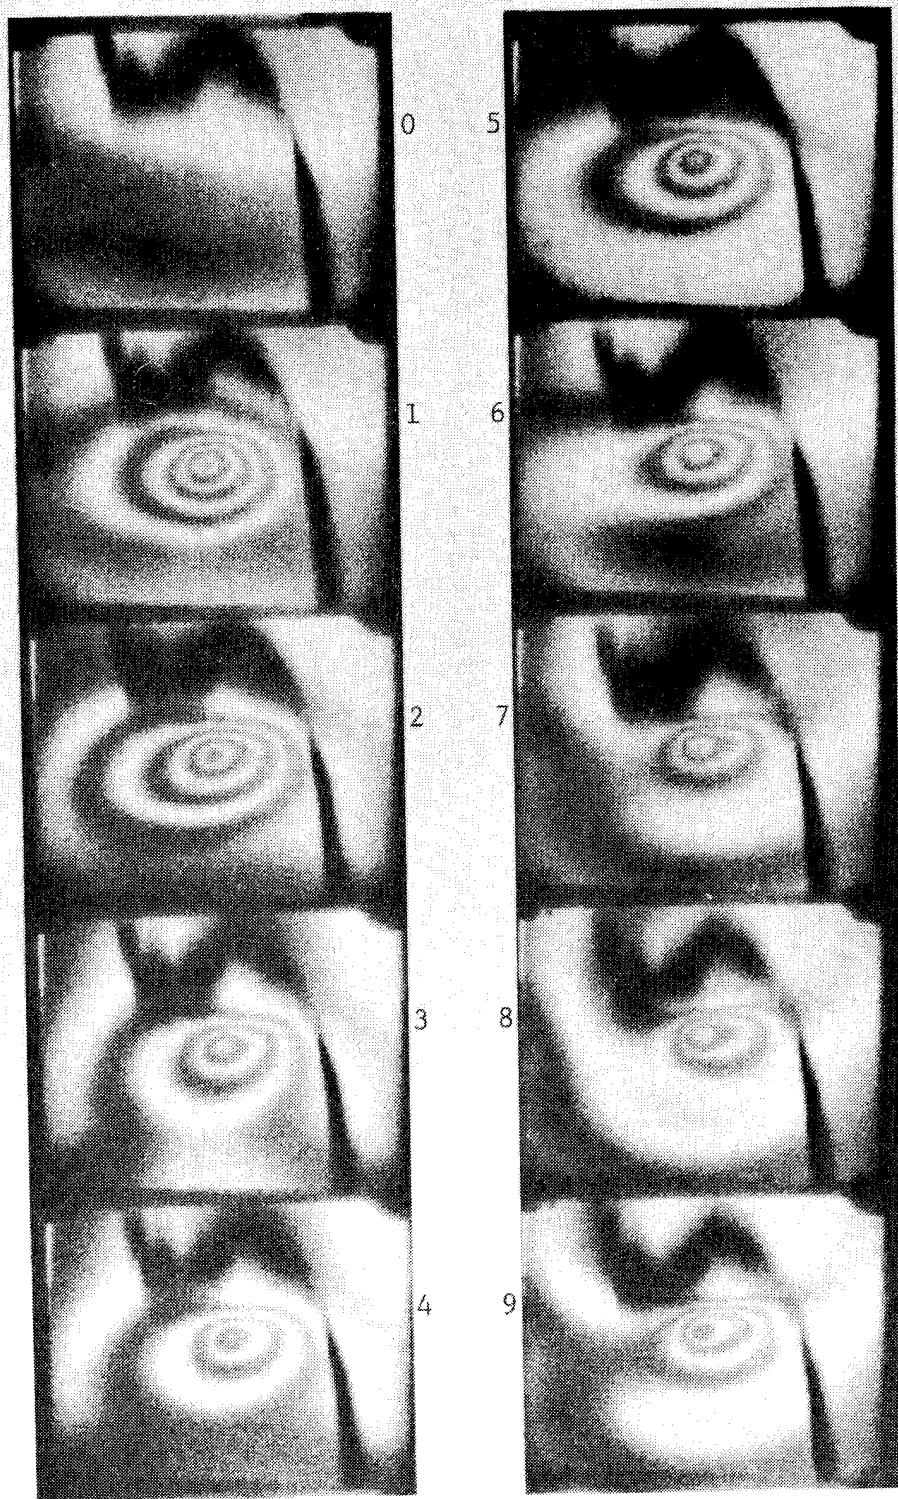
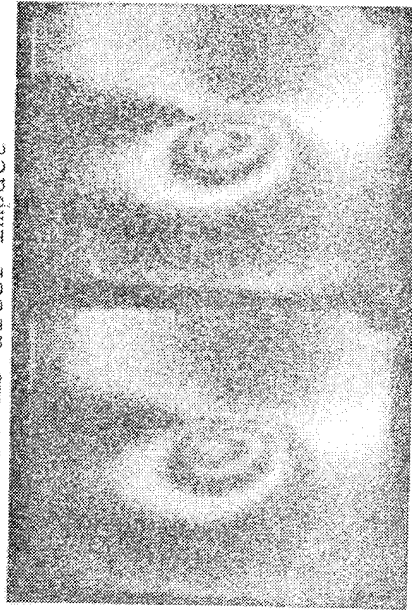
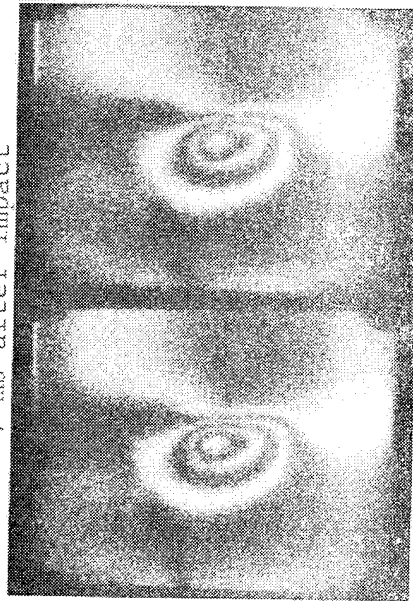
Fig. 13 Test Panel B-4, 21,000 frames/sec.

The photographs for test panel B-4 are shown in fig. 13. The irregular dark pattern in this series of photographs is due to an optical interference. This panel was impacted at the same velocity as B-5 but was preloaded to a strain of 3180 $\mu\text{m}/\text{m}$. Catastrophic failure did not occur until approximately one minute after impact. The back surface permanent deformation was about 0.8 mm out of a total deformation of about 1.3 mm. Comparing this result to that of B-5 indicates some coupling of the in-plane load and the impact.

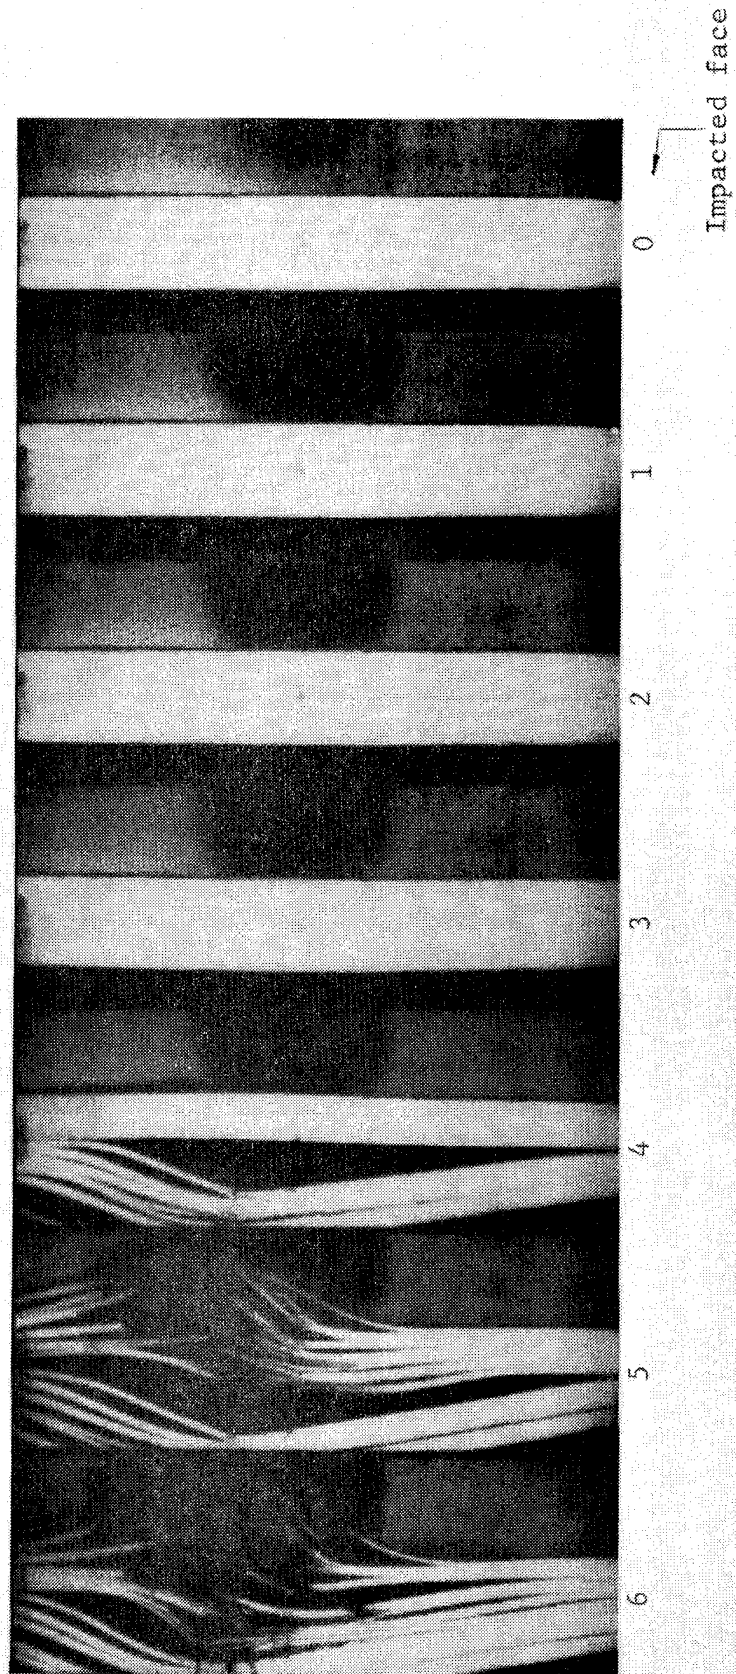
Fig. 14 Test Panel A-3, 15,500 frames/sec. (The portion of the test panel shown is free from support.)

Several test panels were impacted and the side of the specimen photographed. These results are shown in fig. 14 for test panel A-3. The test panel is unsupported over the field of view shown in the film sequence. Frame 0 shows the projectile advancing towards the specimen. Impact was estimated to occur 45 μs after frame 0. Frame 2 shows a central crack extending the whole width of the photograph (85 μs after impact). The plate edge moves approximately 0.25 mm in frame 3. Additional cracks (delaminations) occur

in subsequent frames accompanied by front and rear surface buckling and complete rupture of the panel. This sequence of photographs (highlighted by the early appearance of an edge crack) led to similar tests on two other panels (AB-1, AB-3).

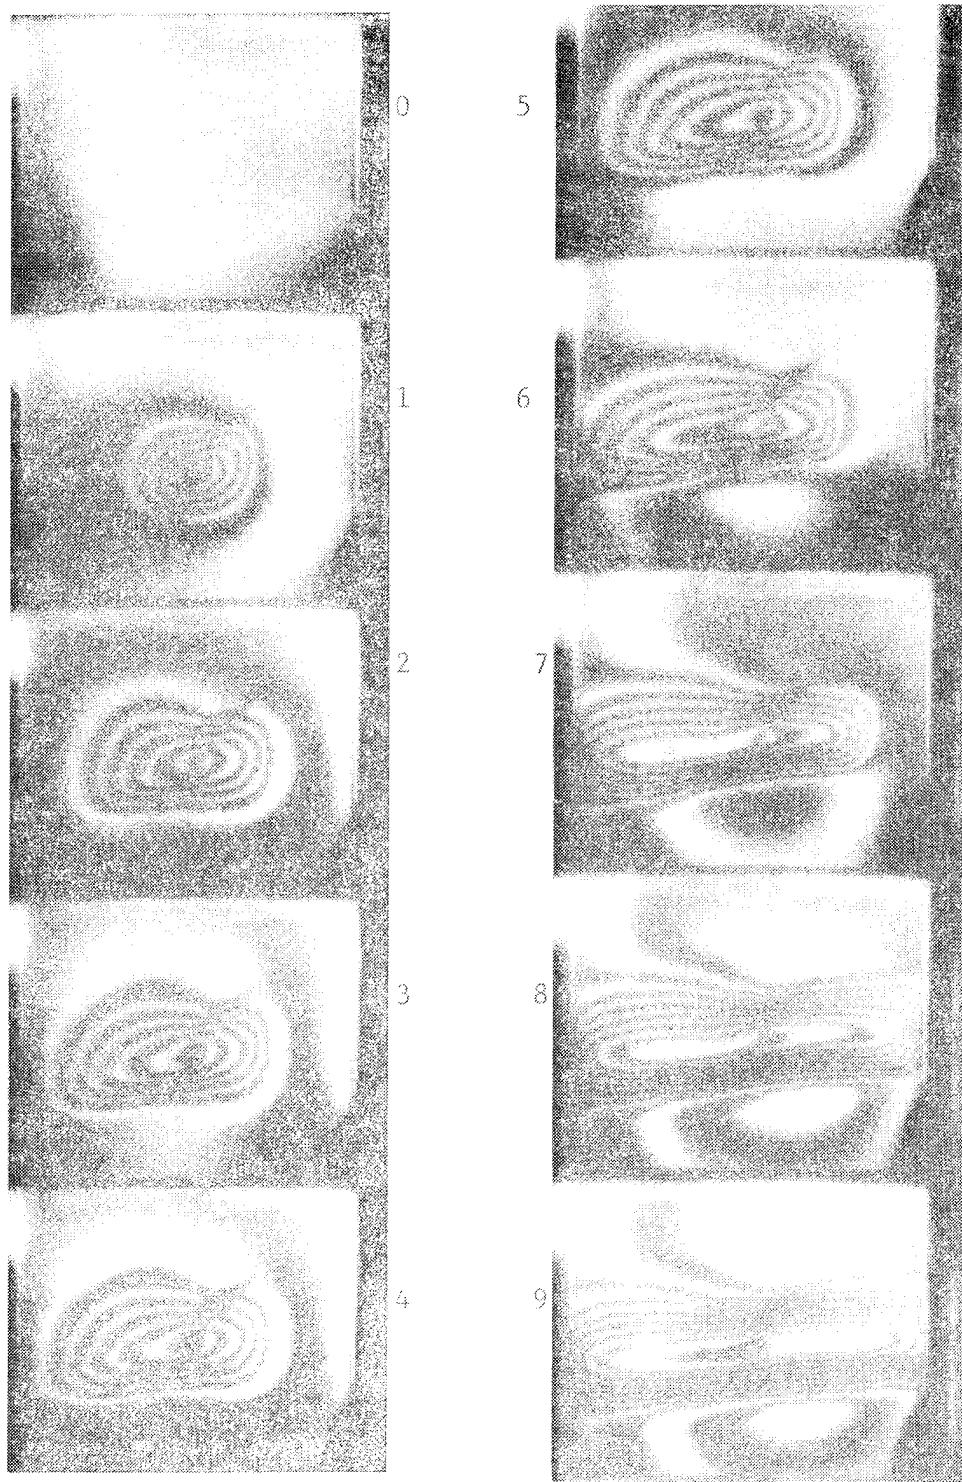
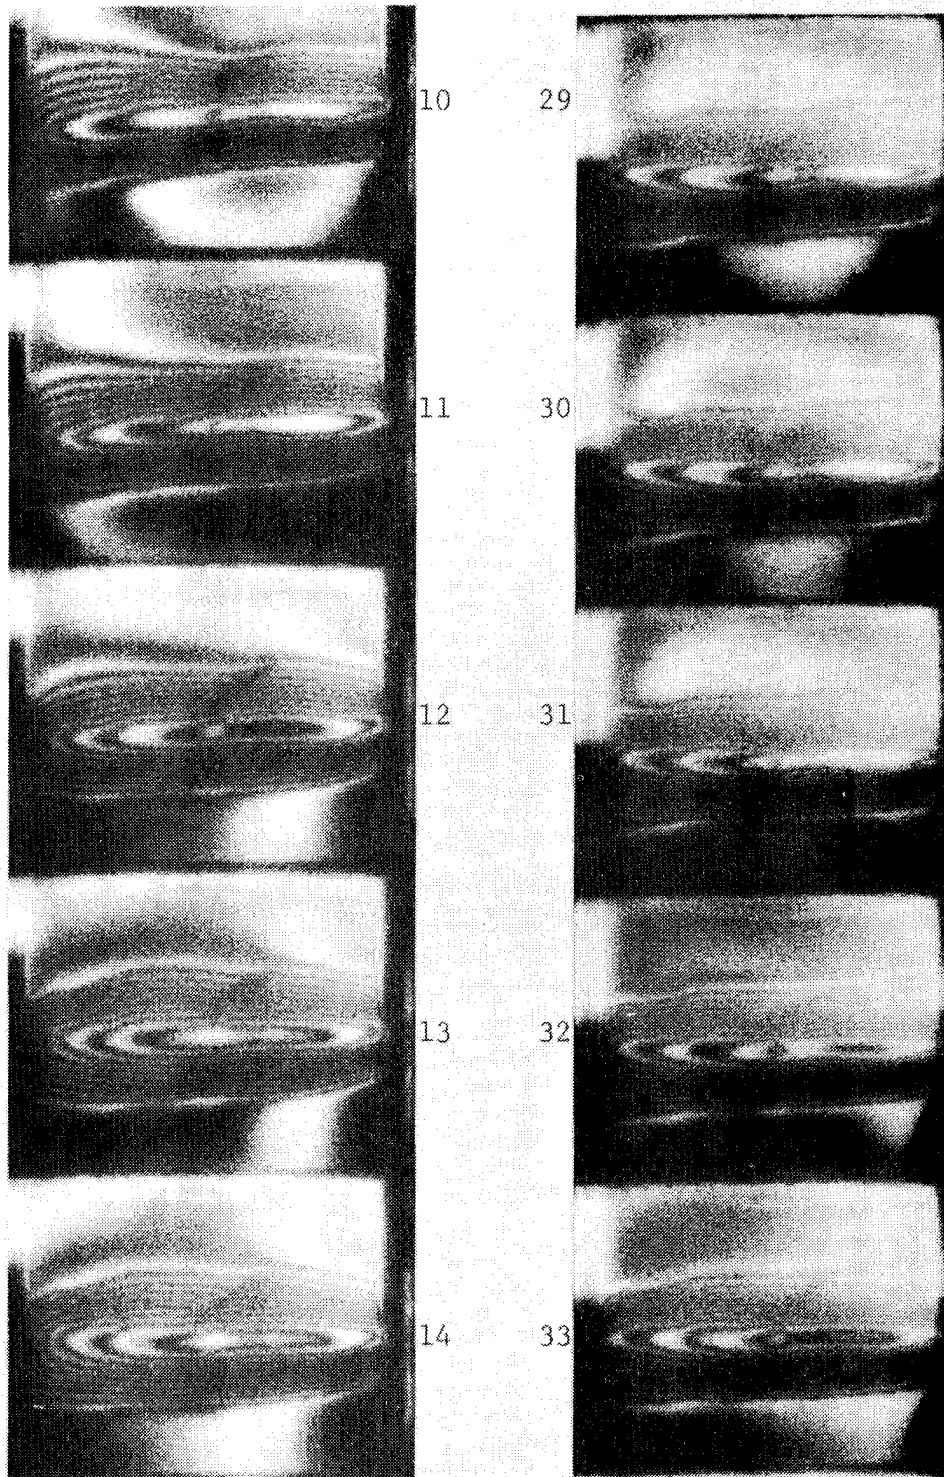
Fig. 15a Test Panel AB-1, 19,800 frames/sec.

Test specimen AB-1 was supported with the small specimen support. A window along the side of the support was cut so that a side view photograph could be made. The panel was supported along its entire length. The moiré pattern obtained for test AB-1 is shown in fig. 15a and the side view is shown in fig. 15b (corresponding to the left side of fig. 15a). Based on the common timing pulse, it was found that frame 0' (side view) is 14 μ s later than frame 0. The characteristic deformation propagated along the specimen width and reached the left side boundary in frame 6. Note that its tip is pointed down about 7 mm. Frame 6' (14 μ s later than 6) shows an initial appearance of a central crack. In frame 7' the crack has extended through the full length of the pictures. This was accompanied by the appearance of a larger crack (5 mm long) pointed downward from the impact level (central

spot). The short crack appearance is attributed to the deformation recorded in frame 6. Frames 29' to 31' show the complete failure of the test specimen.

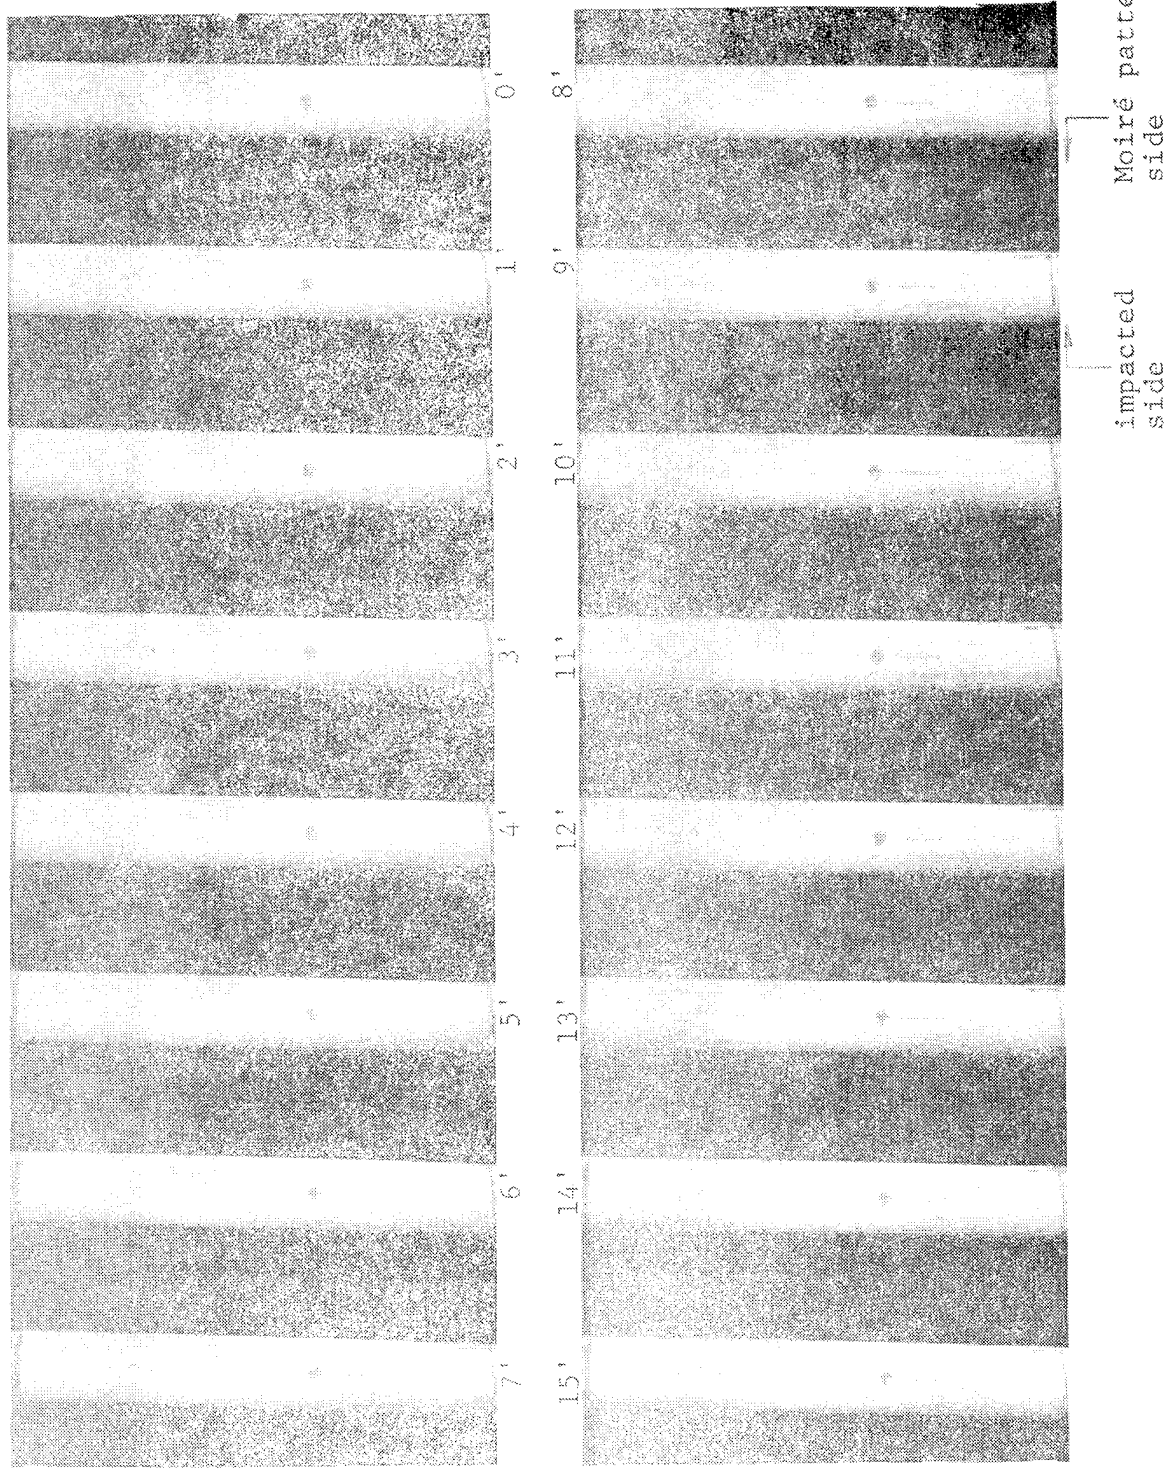
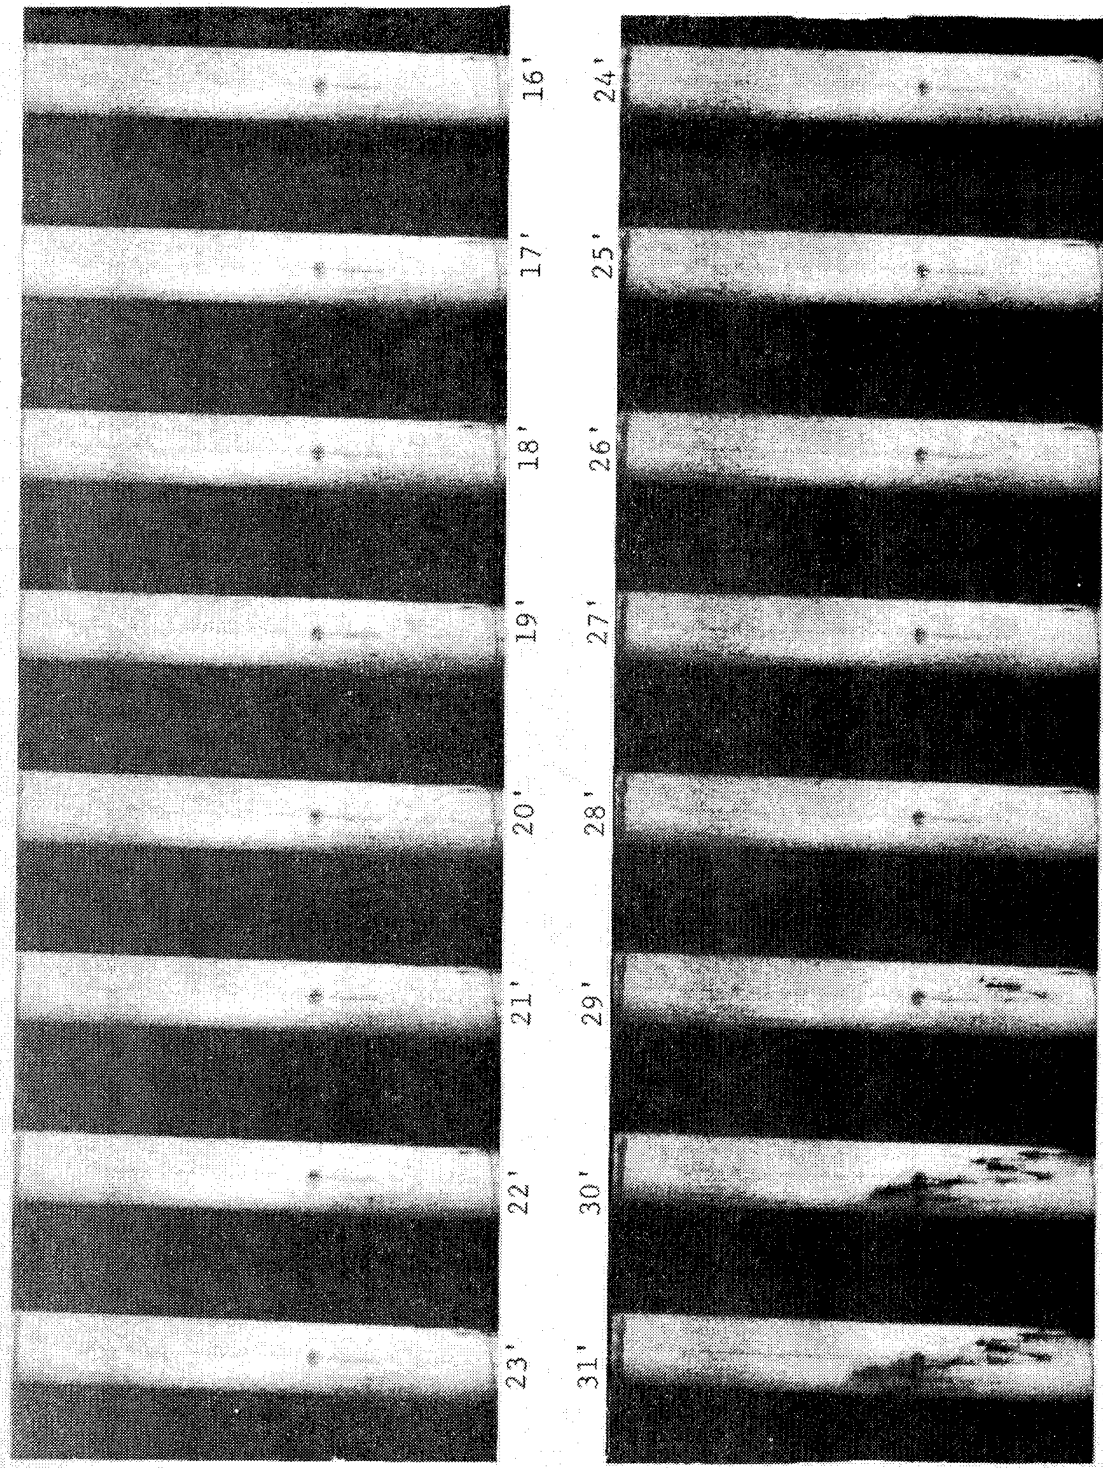
Fig. 15b Test Panel AB-1, 18,150 frames/sec.

to observe its edge. It is clear by looking at the edgewise photograph of the plate (fig. 15b) that the first crack appears at the edge at roughly the time at which in the other picture (fig. 15a) the moiré pattern has reached the left boundary of the plate. As a result of this experiment the front of the internal propagating delamination has been associated with the first or lowest order fringe in the moiré pattern. This assignment of the propagation front is a bit arbitrary; however, for the present purposes of an engineering interpretation of the phenomenon occurring in the damage progression it seemed quite sufficient. Further examination of the propagating damage will use this definition for the extent of the damage region.

Having tentatively established so far when and how rapidly the delamination propagates it is appropriate to comment on the final stages of the compression failure. In fig. 15b, the edge view of a specimen is recorded. The point where a single central crack has appeared and further damage results in a gross fashion occurs in the frames after and including frame 29'. The time corresponding to frame 30' is about 1.5 ms after impact. There are two reasons why this final failure phenomenon may occur at this time. First, since the natural frequency of vibration is on the order of 2000 Hz, the phenomenon might possibly be related

to the vibration of the plate. However, one might expect that the maximum stress occurs during the early part of the plate vibration, namely the quarter period, so that the phenomenon should have occurred at something like 0.1 or 0.2 ms. This clearly did not occur. The second phenomenon that may have caused this occurrence at this time may be the dynamics of the testing machine. It is quite reasonable to expect for testing machines of this size* to have time responses in the millisecond range. For this reason it is assumed that the occurrence of the total damage phenomenon at this time is related to the time it takes for the testing machine to adjust to the damage and more compliant compression specimen.

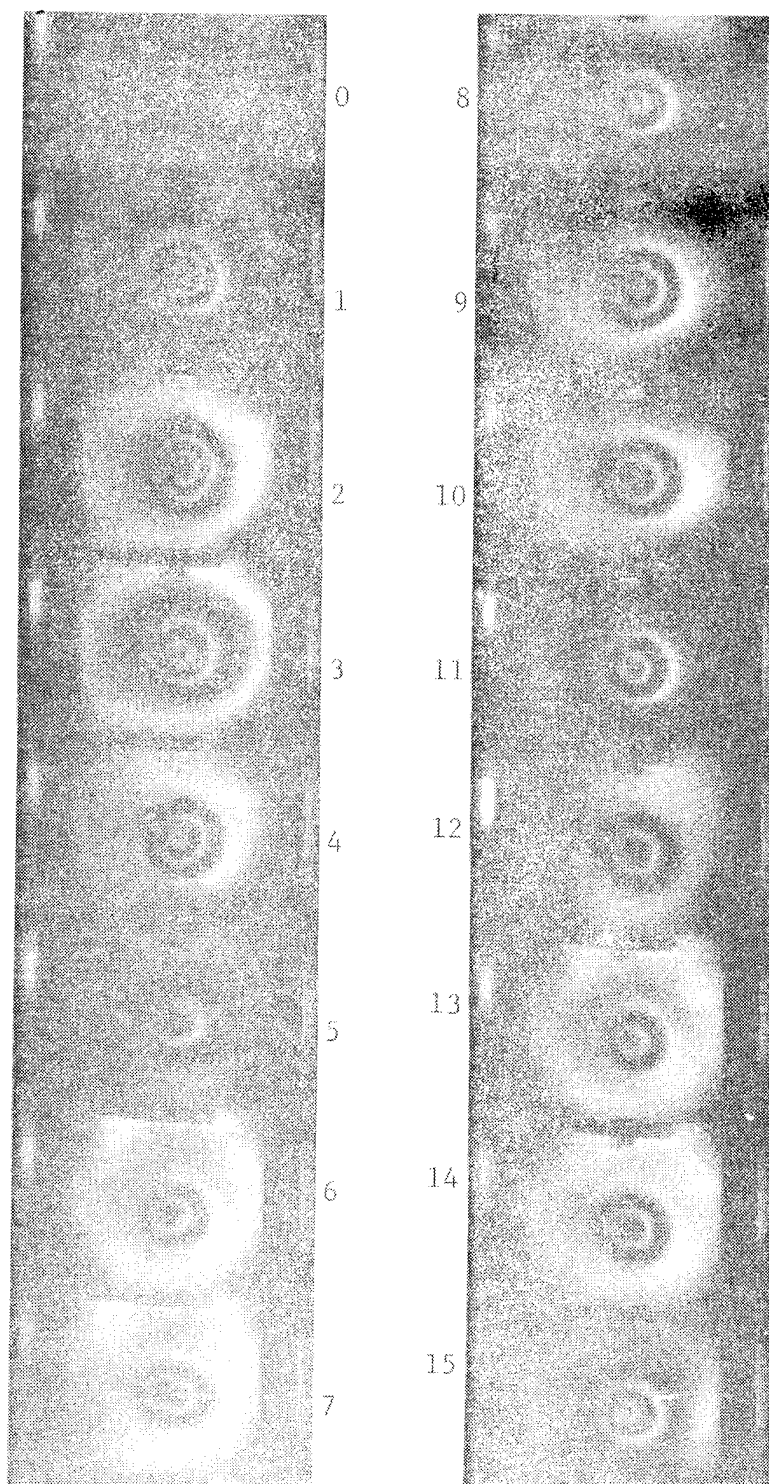
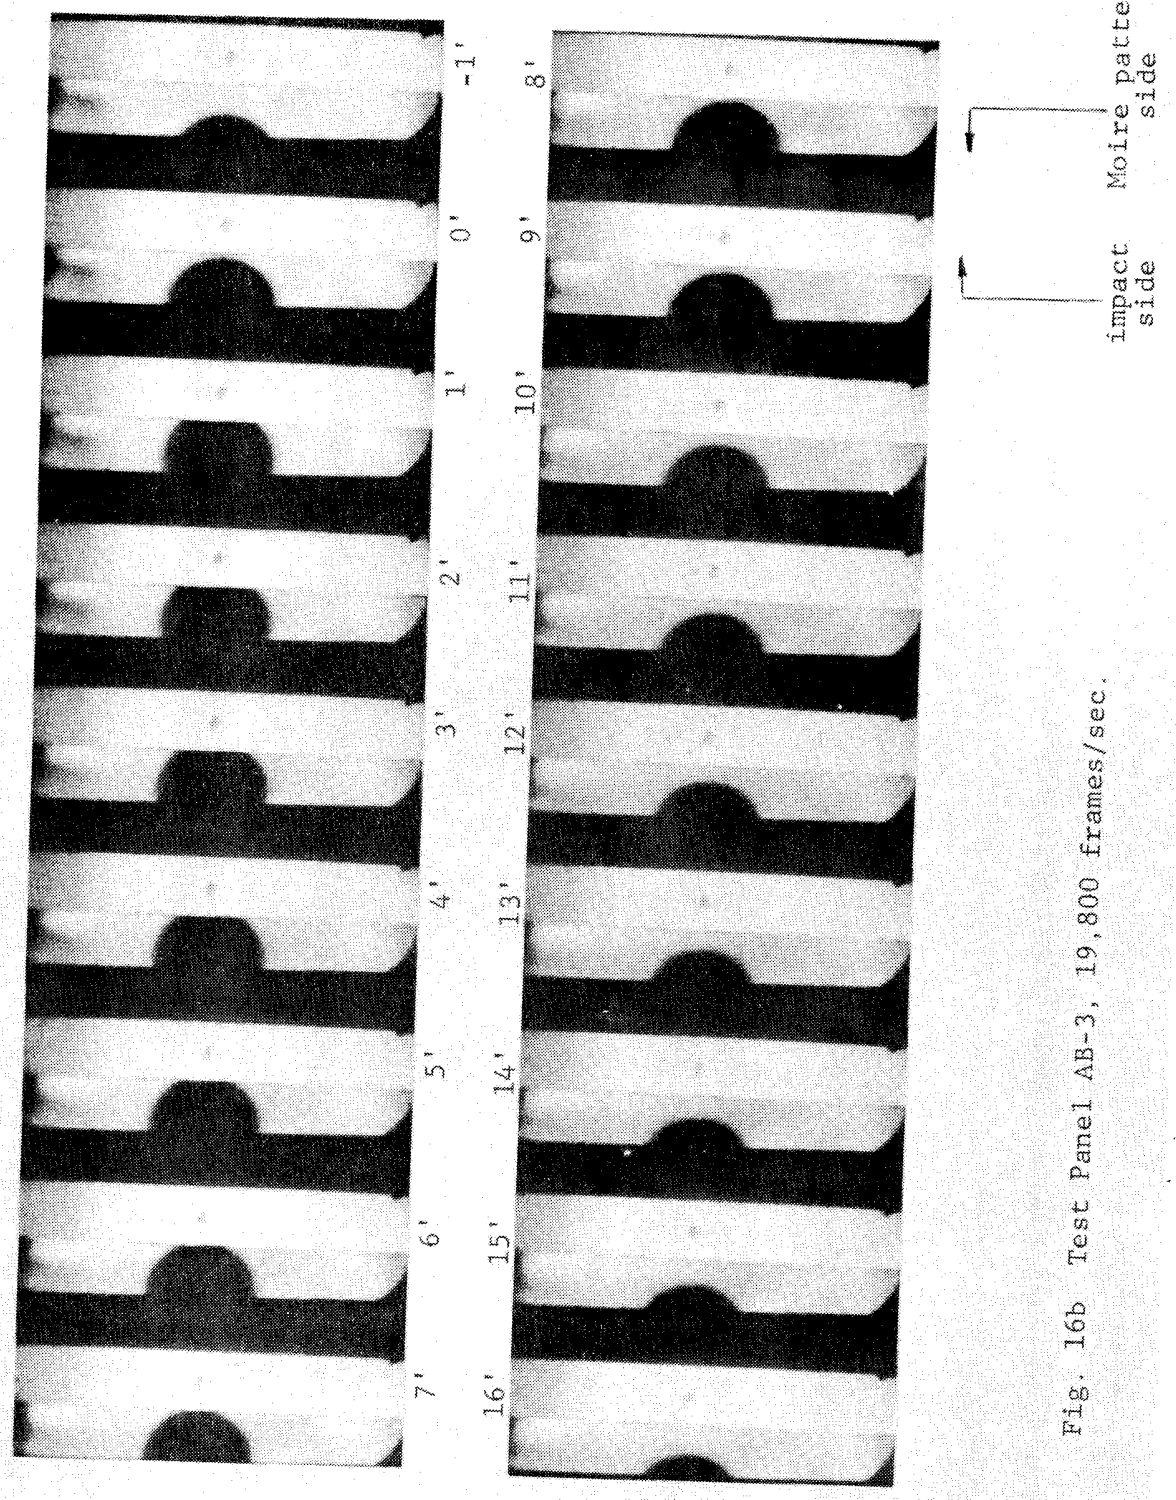
Test panel AB-3 was trimmed to its size from a large specimen type of lot number 2. The photographic results are given in figs. 16a and 16b. Frame 0' was calculated to be 30 μ s before impact and 28 μ s after frame 0. This test panel did not fail catastrophically and there is no evidence of any edge cracks. A permanent surface displacement of the order of 0.6 mm is visible in fig. 16a. The impact duration and rebound velocity were found to be 70 μ s and 7 m/sec from fig. 16b.
